**Flood Control Project Maintenance
Levee Inspections**
LMA District Cover Sheet
Spring 2019 Levee Inspection Results

Reclamation District No. 1001 Nicolaus

Spring 2019 Levee Inspection Results

Waterway	Bank	Unit Miles
Unit No. 01 Yankee Slough	Right	4.12

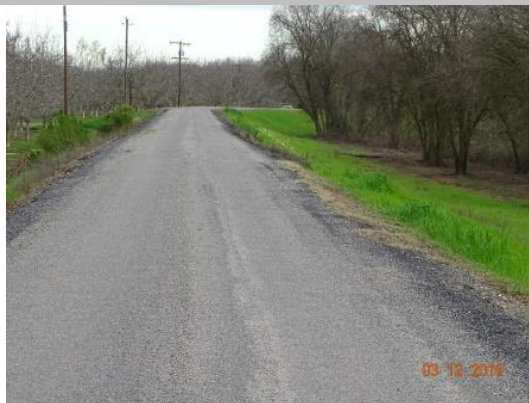
Photo 1 of 1 : SP_2019_RD1001_36_11_20190320_00015.jpg

LM Start	0.00	Rating **	A	Issue No.	11
LM End	3.86	Issue Type +	Ma	Location *	WS
Category	Earthen Levee			GPS Latitude/Longitude	
				Start	End
Item	Vegetation			38.980267 °	38.967114 °
				-121.470113 °	-121.533804 °
DWR ID	DWR_RD1001_01_s_2019_11				
Comment Code					
V1 : Control annual grass and weeds on the levee slopes and easements.					
Inspector Comment					
The annual vegetation is well maintained, Spring 2019.

View looking upstream waterside of the well maintained annual vegetation, Spring 2019.

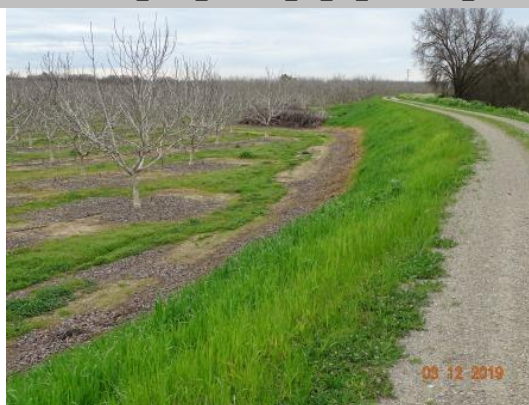
Photo 1 of 1 : SP_2019_RD1001_36_10_20190320_00014.jpg

LM Start	0.00	Rating **	A	Issue No.	10
LM End	3.86	Issue Type +	Ma	Location *	LS
Category	Earthen Levee			GPS Latitude/Longitude	
				Start	End
Item	Vegetation			38.980267 °	38.967114 °
				-121.470113 °	-121.533805 °
DWR ID	DWR_RD1001_01_s_2019_10				
Comment Code					
V1 : Control annual grass and weeds on the levee slopes and easements.					
Inspector Comment					
The annual vegetation is well maintained, Spring 2019.

View looking upstream landside of the well maintained annual vegetation, Spring 2019.

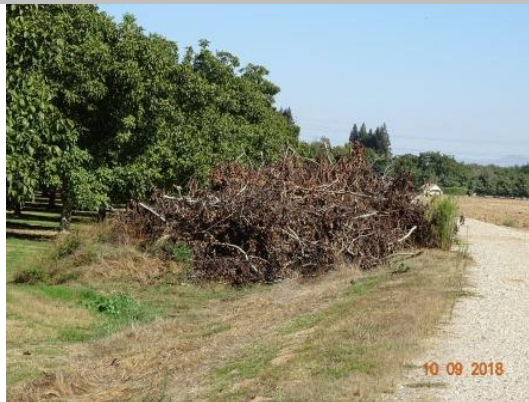
Photo 1 of 1 : SP_2019_RD1001_36_26_20190305_00012.jpg

LM Start	0.37	Rating **	U	Issue No.	26
LM End	0.37	Issue Type +	En	Location *	LS
Category	Earthen Levee			GPS Latitude/Longitude	
				Start	End
Item	Encroachments			38.976294 °	38.976294 °
				-121.474524 °	-121.474524 °
DWR ID	DWR_RD1001_01_f_2016_26				
Comment Code					
PR : Prunings					
Inspector Comment

View of prunings on landside toe looking upstream, Fall 2018.

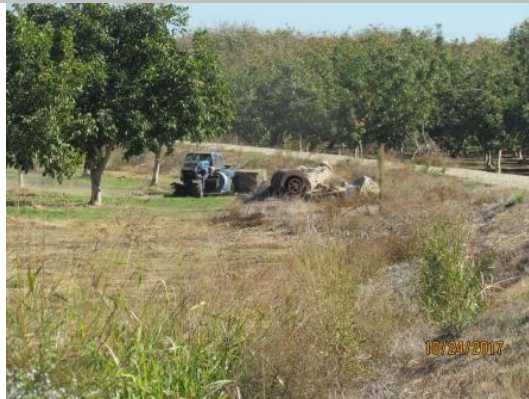
Photo 1 of 1 : SP_2019_RD1001_36_16_20190305_00009.jpg

LM Start	0.42	Rating **	M	Issue No.	16
LM End	0.42	Issue Type +	En	Location *	LS
Category	Earthen Levee			GPS Latitude/Longitude	
				Start	End
Item	Encroachments			38.975782 °	38.975782 °
				-121.475321 °	-121.475321 °
DWR ID	DWR_RD1001_01_s_2015_16				
Comment Code					
DE : Debris					
Inspector Comment

View looking upstream at concrete debris on landside slope.

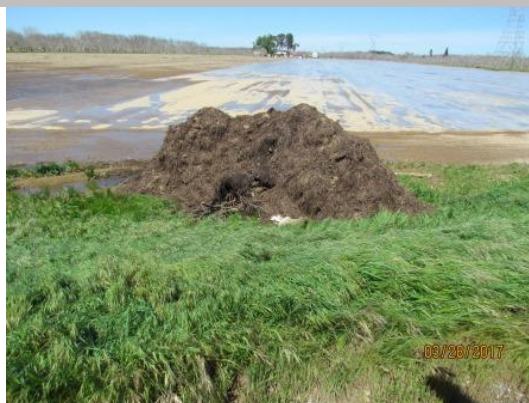
Photo 1 of 1 : SP_2019_RD1001_36_27_20190305_00013.jpg

LM Start	0.51	Rating **	M	Issue No.	27
LM End	0.51	Issue Type +	En	Location *	LS
Category	Earthen Levee			GPS Latitude/Longitude	
				Start	End
Item	Encroachments			38.975308 °	38.975308 °
				-121.476731 °	-121.476731 °
DWR ID	DWR_RD1001_01_s_2017_27				
Comment Code					
PR : Prunings					
Inspector Comment					
Debris/prunings at landside levee toe.

View of debris/prunings at landside levee toe, Spring 2017.

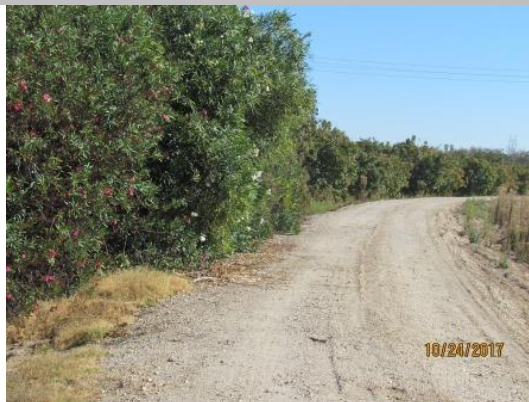
Photo 1 of 1 : SP_2019_RD1001_36_15_20190305_00008.jpg

LM Start	0.95	Rating **	M	Issue No.	15
LM End	0.95	Issue Type +	En	Location *	LS
Category	Earthen Levee			GPS Latitude/Longitude	
				Start	End
Item	Vegetation			38.974569 °	38.974569 °
				-121.484815 °	-121.484815 °
DWR ID	DWR_RD1001_01_s_2012_15				
Comment Code					
V6 : Landscaping					
Inspector Comment					
Landscaping needs to be removed from levee toe.

View of the landscaping on the landside levee slope, Fall 2017.

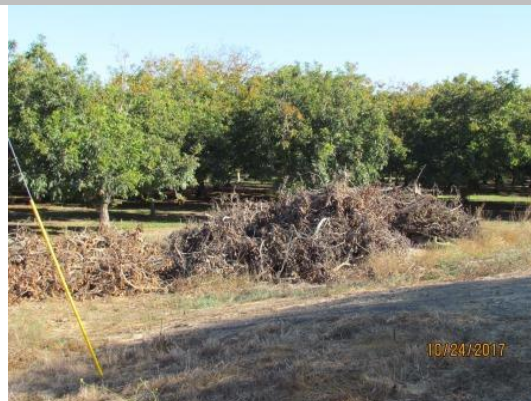
Photo 1 of 1 : SP_2019_RD1001_36_22_20190305_00011.jpg

LM Start	2.01	Rating **	U	Issue No.	22
LM End	2.01	Issue Type +	En	Location *	LS
Category	Earthen Levee			GPS Latitude/Longitude	
				Start	End
Item	Encroachments			38.971093 °	38.971093 °
				-121.502895 °	-121.502895 °
DWR ID	DWR_RD1001_01_f_2016_22				
Comment Code					
PR : Prunings					
Inspector Comment					
Prunings need to be removed.

View of prunings on the landside toe looking upstream. Fall 2017.

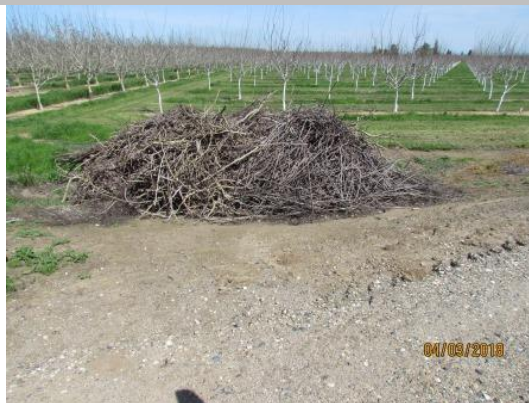
Photo 1 of 1 : SP_2019_RD1001_36_6_20190305_00004.jpg

LM Start	2.22	Rating **	M	Issue No.	6
LM End	2.22	Issue Type +	En	Location *	LS
Category	Earthen Levee			GPS Latitude/Longitude	
				Start	End
Item	Encroachments			38.969304 °	38.969304 °
				-121.506050 °	-121.506050 °
DWR ID	DWR_RD1001_01_f_2014_6				
Comment Code					
PR : Prunings					
Inspector Comment					
Prunings still at levee toe need to be removed.

This photo was taken of the landside looking upstream at prunings stacked up at the levee toe.

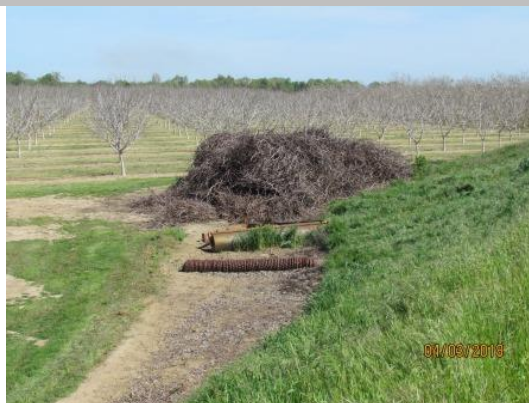
Photo 1 of 1 : SP_2019_RD1001_36_14_20190305_00007.jpg

LM Start	2.97	Rating **	M	Issue No.	14
LM End	2.97	Issue Type +	En	Location *	LS
Category	Earthen Levee			GPS Latitude/Longitude	
				Start	End
Item	Encroachments			38.966651 °	38.966651 °
				-121.518940 °	-121.518940 °
DWR ID	DWR_RD1001_01_s_2018_14				
Comment Code					
PR : Prunings					
Inspector Comment					
Remove prunings from levee toe.

View looking upstream landside of prunings that have been placed at levee toe.

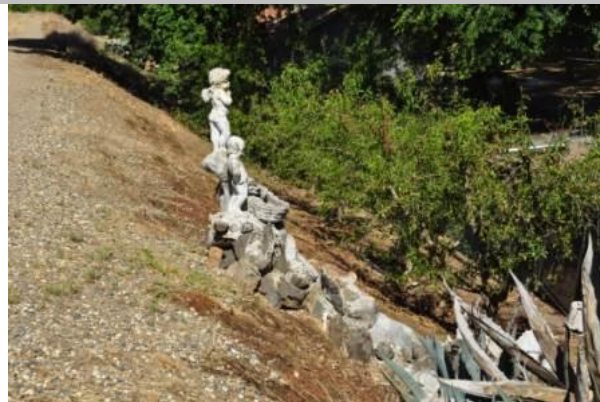
Photo 1 of 2 : SP_2019_RD1001_36_5_20190305_00002.jpg

LM Start	3.12	Rating **	M	Issue No.	5
LM End	3.17	Issue Type +	En	Location *	LS
Category	Earthen Levee			GPS Latitude/Longitude	
				Start	End
Item	Vegetation			38.965663 °	38.965705 °
				-121.521023 °	-121.522098 °
DWR ID	DWR_RD1001_01_s_2012_5				
Comment Code					
V6 : Landscaping					
Inspector Comment

Unit 1 Landscaping on levee slope. L/S

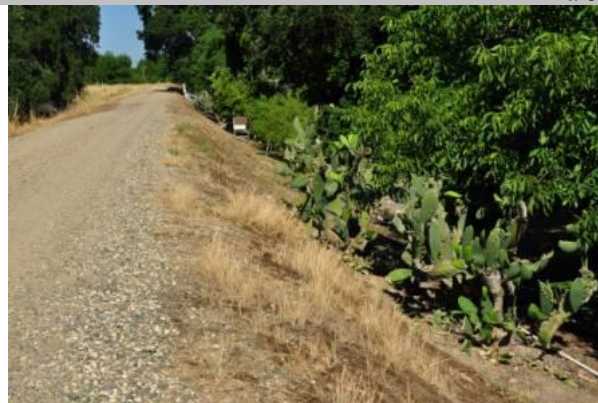
Photo 2 of 2 : SP_2019_RD1001_36_5_20190305_00003.jpg

LM Start	3.12	Rating **	M	Issue No.	5 (cont)	
LM End	3.17	Issue Type +	En	Location *	LS	
Category	Earthen Levee			GPS Latitude/Longitude		
				Start		End
Item	Vegetation			38.965663 °		38.965705 °
				-121.521023 °		-121.522098 °
DWR ID	DWR_RD1001_01_s_2012_5					
Comment Code						
V6 : Landscaping						
Inspector Comment

View of landscaping on landside slope.

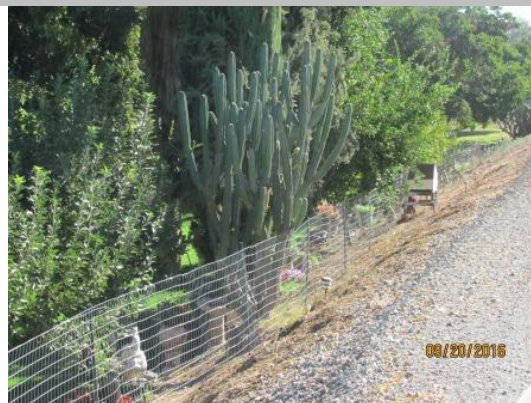
Photo 1 of 1 : SP_2019_RD1001_36_20_20190305_00010.jpg

LM Start	3.13	Rating **	M	Issue No.	20
LM End	3.17	Issue Type +	En	Location *	LS
Category	Earthen Levee			GPS Latitude/Longitude	
				Start	End
Item	Encroachments			38.965663 °	38.965672 °
				-121.521267 °	-121.521919 °
DWR ID	DWR_RD1001_01_f_2016_20				
Comment Code					
FE : Fence					
Inspector Comment					
Land owner has installed an unpermitted fence on the landside levee slope.

View of a fence on the landside levee slope looking upstream.

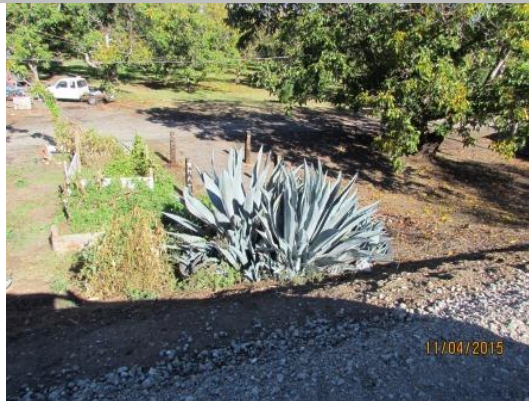
Photo 1 of 1 : SP_2019_RD1001_36_4_20190305_00001.jpg

LM Start	3.21	Rating **	U	Issue No.	4
LM End	3.21	Issue Type +	En	Location *	LS
Category	Earthen Levee			GPS Latitude/Longitude	
				Start	End
Item	Vegetation			38.965699 °	38.965699 °
				-121.522790 °	-121.522790 °
DWR ID	DWR_RD1001_01_f_2015_4				
Comment Code					
V6 : Landscaping					
Inspector Comment

View of the landscaping at the landside levee toe.

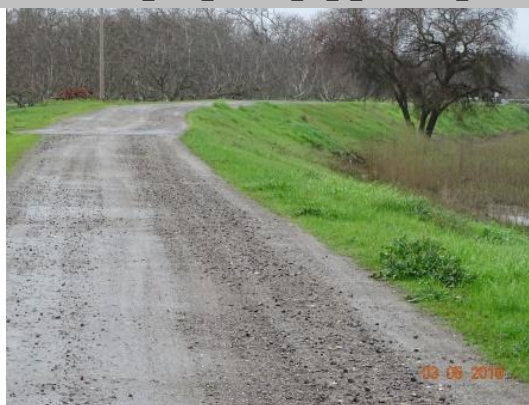
Photo 1 of 1 : SP_2019_RD1001_35_8_20190320_00028.jpg

LM Start	0.01	Rating **	A	Issue No.	8
LM End	3.64	Issue Type +	Ma	Location *	WS
Category	Earthen Levee			GPS Latitude/Longitude	
				Start	End
Item	Vegetation			38.971342 °	38.965811 °
				-121.473997 °	-121.533591 °
DWR ID	DWR_RD1001_02_s_2019_8				
Comment Code					
V1 : Control annual grass and weeds on the levee slopes and easements.					
Inspector Comment					
The annual vegetation is well maintained, Spring 2019.

View looking downstream waterside at the well maintained annual vegetation, Spring 2019.

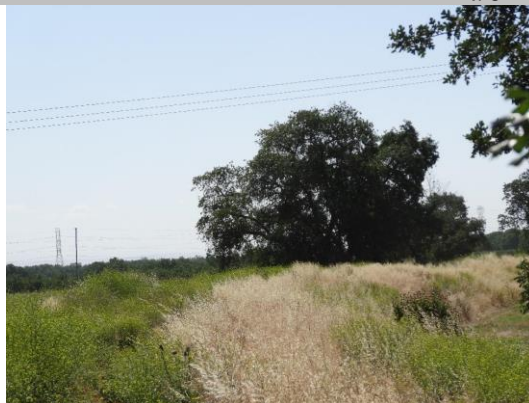
Photo 1 of 3 : UCIP_SP_2019_41673_22745.jpg

Comment Code					
Inspector Comment					
FS_ID:41673 DS_ID:22536 EP_NO: 5562 Repair Type: Non-Urgent Crossing Status: Found UCIP Comments: 05/23/2013 Pipe appears abandoned and if so should be done so properly. WS pipe plugged with stopper. Seems abandoned. Only abandoned pump base found. (P. Amatya - DWR UCIP) FIELD_STRUCT_DESC: 6-inch coated steel irrigation pipe through the levee, 3.5 feet below the crown. Metal cutoff collar placed on the pipe at the center of the levee crown. Pump was removed. Pump base on the waterside (WS) berm. Shutoff valve on the discharge side of the pump. Foot valve below water on the intake side of the pump. Siphon breaker on the landside (LS) shoulder. Pipe discharges into underground irrigation system on the LS. Power pole and meter box, 10 feet from the landward toe. 1.5-inch flexible conduit through levee, 3.5 feet below the crown. (Pump and 6-inch irrigation pipe authorized under Permit No. 5562, 1966 - Samuel B. Single). [Additional Reference(s): DWR Levee Log, 1993]. FS Date: 5/23/2013

Levee Crown: dense vegetation on levee crown and sides.

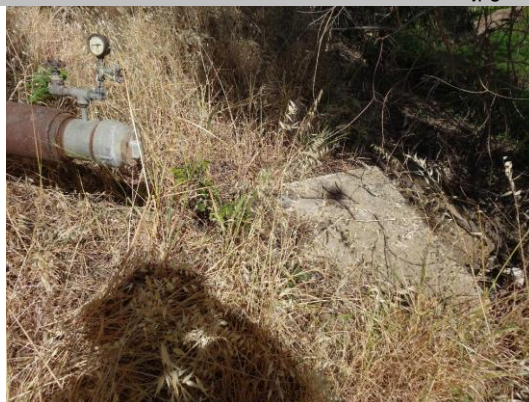
Photo 2 of 3 : UCIP_SP_2019_41673_22744.jpg

WS- plugged pipe and pump base.

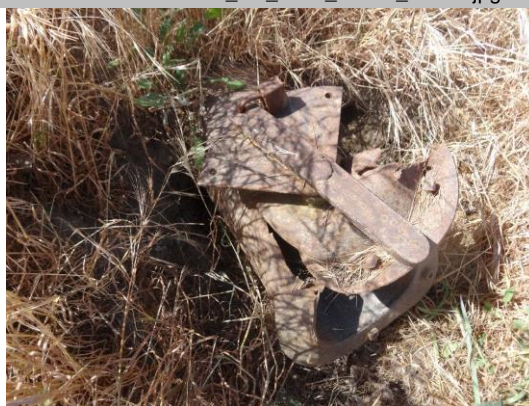
Photo 1 of 3 : UCIP_SP_2019_50740_22753.jpg

Comment Code					
Inspector Comment					
FS_ID:50740 DS_ID:22529 EP_NO: 2281 Repair Type: Non-Urgent Crossing Status: Not Found UCIP Comments: 01/17/2019 Records detailing the actions taken for the removal of the 7-inch pipe were recorded under file name LI10703_79259 document 20141008 CVFPB letter of acknowledgement available through permit records. (O. Magana - DWR UCIP) 07/13/2016 According to district president Joe Henderson, pipe was removed 2-3 years ago. No permit for removal found or evidence of pipe or its removal found. (K. Fazel - UCIP) 05/23/2013:- leaky pipe end and erosion on WS.- cracked dirt mound on LS - seems not been used for some time. (P. Amatya - DWR) FIELD_STRUCT_DESC: *REMOVED* 7-inch steel irrigation pipe through the levee, 1.9 feet below the crown. Portable pump mounted on the bank during the summer months. Control valve on the waterside (WS). Steel plate bolted on the WS end during the winter months. Pipe discharges into a 30-inch concrete standpipe at the landside (LS) toe. (Pump and 7-inch irrigation pipe authorized under Permit No. 2281, 1956 - Willard R. Brown; 7-inch pipe through levee and concrete standpipe located on LS were removed as part of the 2013 USACE Periodic Inspection). [Additional Reference(s): DWR Levee Log, 1993]. FS Date: 7/13/2016

WS- end of the pipe.

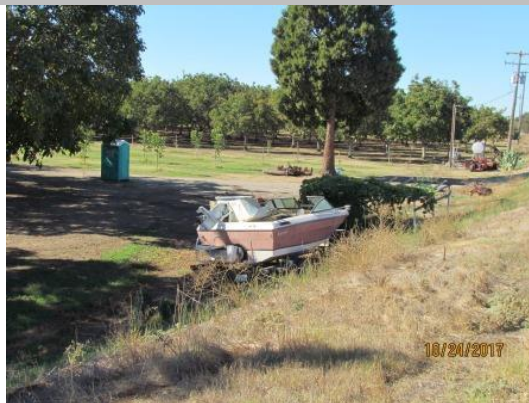
Photo 2 of 2 : SP_2019_RD1001_35_19_20190305_00010.jpg

LM Start	0.53	Rating **	M	Issue No.	19 (cont)	
LM End	0.53	Issue Type +	En	Location *	LS	
Category	Earthen Levee			GPS Latitude/Longitude		
				Start		End
Item	Encroachments			38.974371 °		38.974371 °
				-121.481223 °		-121.481223 °
DWR ID	DWR_RD1001_02_f_2016_19					
Comment Code						
AV : Abandoned vehicles						
Inspector Comment						
Remove boat parked at the landside levee toe, Fall 2018.

View of a boat at the landside levee toe. Fall 2017.

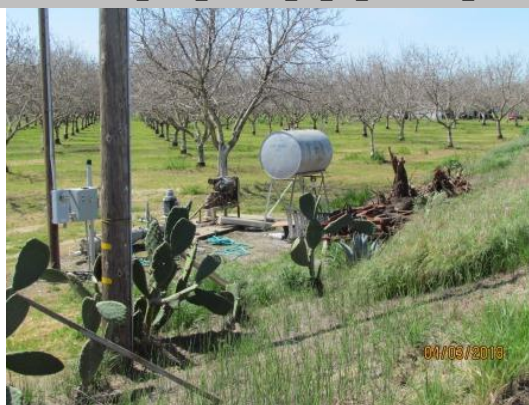
Photo 1 of 1 : SP_2019_RD1001_35_21_20190305_00011.jpg

LM Start	0.54	Rating **	M	Issue No.	21
LM End	0.54	Issue Type +	En	Location *	LS
Category	Earthen Levee			GPS Latitude/Longitude	
				Start	End
Item	Encroachments			38.974348 °	38.974348 °
				-121.481498 °	-121.481498 °
DWR ID	DWR_RD1001_02_f_2016_21				
Comment Code					
TA : Tank					
Inspector Comment					
Tank at landside levee toe needs to be removed from easement.

View looking downstream landside, equipment has been moved but fuel tank remains.

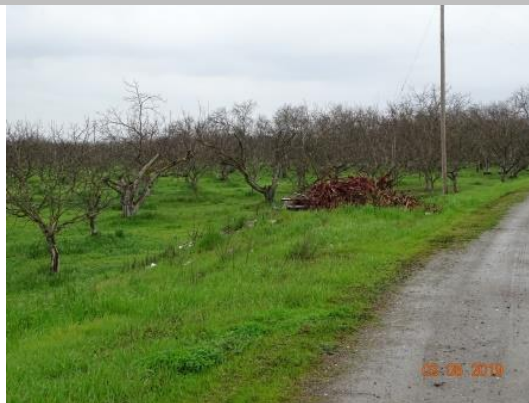
Photo 1 of 2 : SP_2019_RD1001_35_22_20190320_00029.jpg

LM Start	0.78	Rating **	M	Issue No.	22
LM End	0.78	Issue Type +	En	Location *	LS
Category	Earthen Levee			GPS Latitude/Longitude	
				Start	End
Item	Encroachments			38.973509 °	38.973509 °
				-121.485668 °	-121.485668 °
DWR ID	DWR_RD1001_02_f_2016_22				
Comment Code					
DE : Debris					
Inspector Comment					
Debris has been piled up again, Spring 2019.

View looking downstream of debris being piled up on the landside levee slope, Spring 2019.

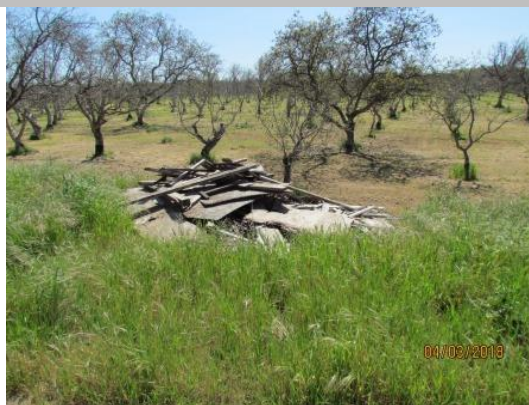
Photo 2 of 2 : SP_2019_RD1001_35_22_20190305_00012.jpg

LM Start	0.78	Rating **	M	Issue No.	22 (cont)
LM End	0.78	Issue Type +	En	Location *	LS

View of debris pile on the landside levee slope looking downstream, Spring 2018.

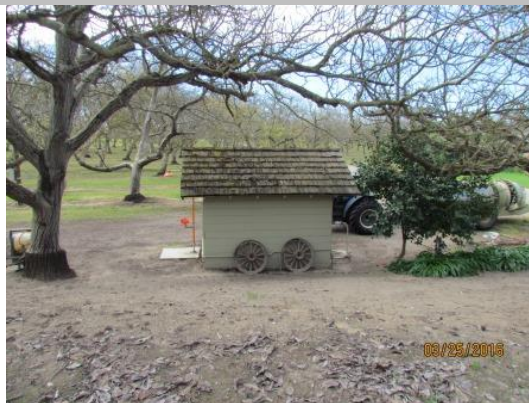
Photo 1 of 1 : SP_2019_RD1001_35_18_20190305_00008.jpg

LM Start	1.71	Rating **	M	Issue No.	18
LM End	1.71	Issue Type +	En	Location *	LS
Category	Earthen Levee			GPS Latitude/Longitude	
				Start	End
Item	Encroachments			38.970264 °	38.970264 °
				-121.501343 °	-121.501343 °
DWR ID	DWR_RD1001_02_s_2016_18				
Comment Code					
BU : Building					
Inspector Comment

Shed at landside toe.

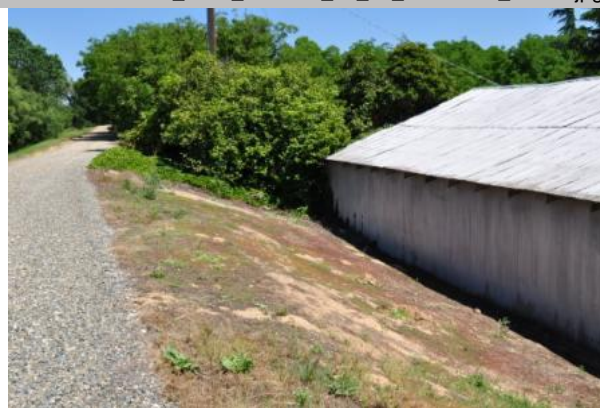
Photo 1 of 1 : SP_2019_RD1001_35_10_20190305_00003.jpg

LM Start	1.74	Rating **	U	Issue No.	10
LM End	1.74	Issue Type +	En	Location *	LS
Category	Earthen Levee			GPS Latitude/Longitude	
				Start	End
Item	Vegetation			38.970353 °	38.970353 °
				-121.501935 °	-121.501935 °
DWR ID	DWR_RD1001_02_s_2012_10				
Comment Code					
V6 : Landscaping					
Inspector Comment

RD 1001 Unit 2 - L/S -Landscaping - Trees

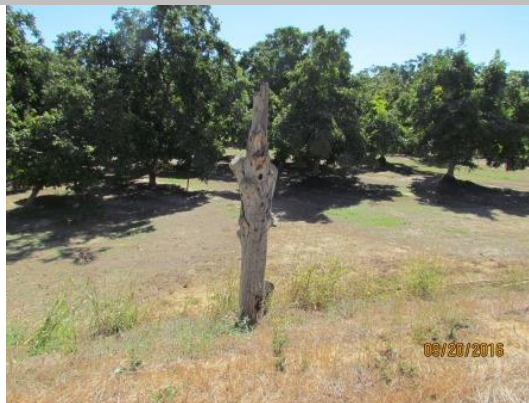
Photo 1 of 1 : SP_2019_RD1001_35_6_20190305_00002.jpg

LM Start	1.88	Rating **	M	Issue No.	6
LM End	1.88	Issue Type +	En	Location *	LS
Category	Earthen Levee			GPS Latitude/Longitude	
				Start	End
Item	Encroachments			38.969489 °	38.969489 °
				-121.504155 °	-121.504155 °
DWR ID	DWR_RD1001_02_f_2015_6				
Comment Code					
TR : Tree or limb					
Inspector Comment					
Large stump at the landside levee toe should be removed, Fall 2018.

View of large stump at the landside levee toe.

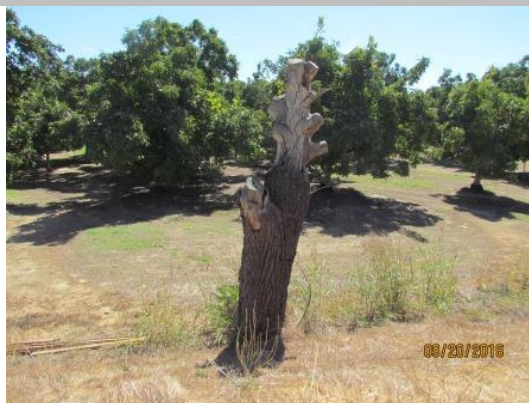
Photo 1 of 1 : SP_2019_RD1001_35_13_20190305_00006.jpg

LM Start	1.89	Rating **	M	Issue No.	13
LM End	1.89	Issue Type +	En	Location *	LS
Category	Earthen Levee			GPS Latitude/Longitude	
				Start	End
Item	Encroachments			38.969423 °	38.969423 °
				-121.504225 °	-121.504225 °
DWR ID	DWR_RD1001_02_f_2015_13				
Comment Code					
TR : Tree or limb					
Inspector Comment					
Large stump at the landside levee toe should be removed, Fall 2018.

View of large stump at the landside levee toe.

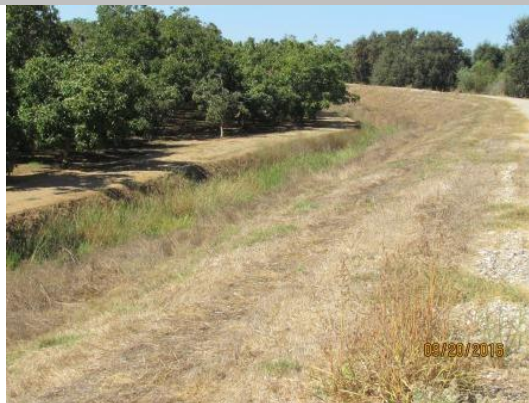
Photo 1 of 1 : SP_2019_RD1001_35_52_20190305_00017.jpg

LM Start	2.28	Rating **	M	Issue No.	52
LM End	2.52	Issue Type +	En	Location *	LS
Category	Earthen Levee			GPS Latitude/Longitude	
				Start	End
Item	Encroachments			38.967402 °	38.967515 °
				-121.510850 °	-121.515270 °
DWR ID	DWR_RD1001_02_s_2012_52				
Comment Code					
DT : Ditch					
Inspector Comment

View of landside irrigation ditch looking downstream.

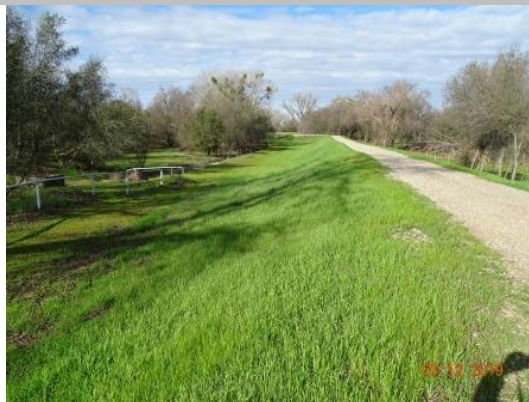
Photo 1 of 2 : SP_2019_RD1001_37_6_20190320_00038.jpg

LM Start	0.01	Rating **	A	Issue No.	6
LM End	12.57	Issue Type +	Ma	Location *	LS
Category	Earthen Levee			GPS Latitude/Longitude	
				Start	End
Item	Vegetation			39.006576 °	38.941182 °
				-121.375131 °	-121.567543 °
DWR ID	DWR_RD1001_03_s_2019_6				
Comment Code					
V1 : Control annual grass and weeds on the levee slopes and easements.					
Inspector Comment					
Well maintained annual vegetation, Spring 2019.

View looking downstream landside east of the RR Tracks at the well maintained annual vegetation, Spring 2019.

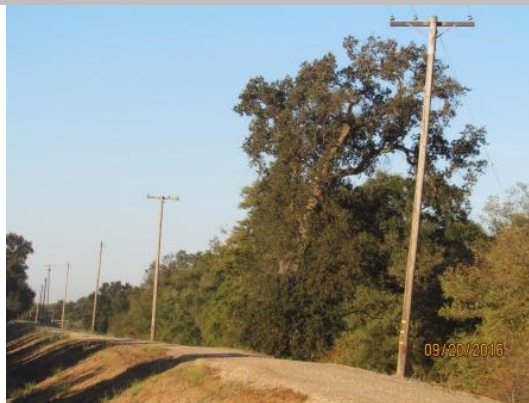
Photo 1 of 1 : SP_2019_RD1001_37_3_20190305_00001.jpg

LM Start	1.16	Rating **	M	Issue No.	3
LM End	1.78	Issue Type +	En	Location *	WS
Category	Earthen Levee			GPS Latitude/Longitude	
				Start	End
Item	Encroachments			39.005730 °	38.999534 °
				-121.396111 °	-121.404395 °
DWR ID	DWR_RD1001_03_s_2012_3				
Comment Code					
PO : Pole					
Inspector Comment					
Unpermitted Power Poles on the crown along waterside shoulder.

View of Power Poles along waterside shoulder.

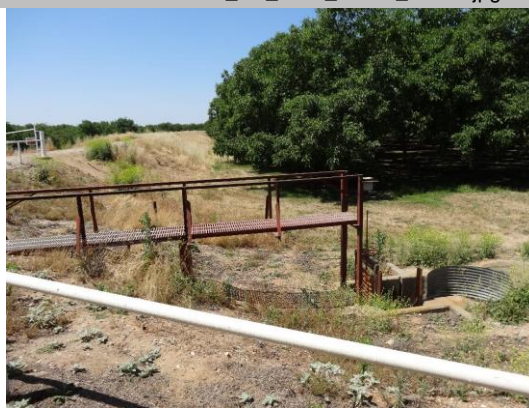
Photo 1 of 3 : UCIP_SP_2019_41727_23325.jpg

Comment Code						
Inspector Comment						
FS_ID:41727 DS_ID:22561 EP_NO: 4505 Repair Type: Non-Urgent Crossing Status: Found UCIP Comments: 05/21/2013 Two small steel pipes sleeved through 30-inch CMP may be a compliance issue as slidegate cannot close.- this may have been converted into drainage pipe (?) - big CMP standpipe on WS. (P. Amatya - DWR UCIP) FIELD_STRUCT_DESC: 30-inch concrete encased corrugated metal irrigation pipe through the levee, 11 feet below the crown. Concrete headwall and slide gate at the waterside (WS) toe, removed. Metal walkway on the WS to the slide gate. Pipe discharges into a 48-inch concrete standpipe at the landside (LS) toe. Two vertical pumps. (30-inch concrete encased corrugated metal irrigation pipe authorized under Permit No. 4505, 1964 - State of California, Department of Public Works, Division of Highways). [Additional Reference(s): DWR Levee Log, 1993. USACE Sacramento O&M Manual 141.1, August 1955, (Station 949+00), 30-inch steel pipe referenced]. FS Date: 5/21/2013

WS- steel walkway, CMP and concrete headwall

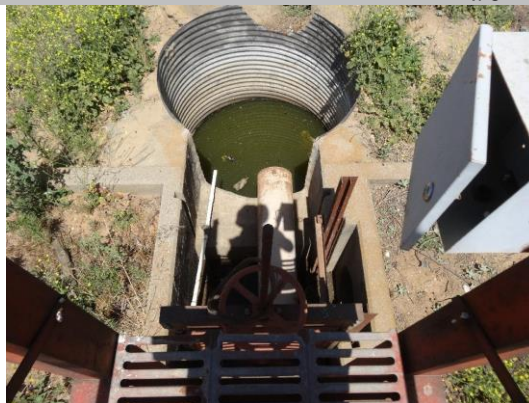
Photo 2 of 3 : UCIP_SP_2019_41727_23324.jpg

Comment Code						
Inspector Comment						
FS_ID:41727 DS_ID:22561 EP_NO: 4505 Repair Type: Non-Urgent Crossing Status: Found UCIP Comments: 05/21/2013 Two small steel pipes sleeved through 30-inch CMP may be a compliance issue as slidegate cannot close.- this may have been converted into drainage pipe (?) - big CMP standpipe on WS. (P. Amatya - DWR UCIP) FIELD_STRUCT_DESC: 30-inch concrete encased corrugated metal irrigation pipe through the levee, 11 feet below the crown. Concrete headwall and slide gate at the waterside (WS) toe, removed. Metal walkway on the WS to the slide gate. Pipe discharges into a 48-inch concrete standpipe at the landside (LS) toe. Two vertical pumps. (30-inch concrete encased corrugated metal irrigation pipe authorized under Permit No. 4505, 1964 - State of California, Department of Public Works, Division of Highways). [Additional Reference(s): DWR Levee Log, 1993. USACE Sacramento O&M Manual 141.1, August 1955, (Station 949+00), 30-inch steel pipe referenced]. FS Date: 5/21/2013

WS- CMP standpipe, pipes and concrete headwall.

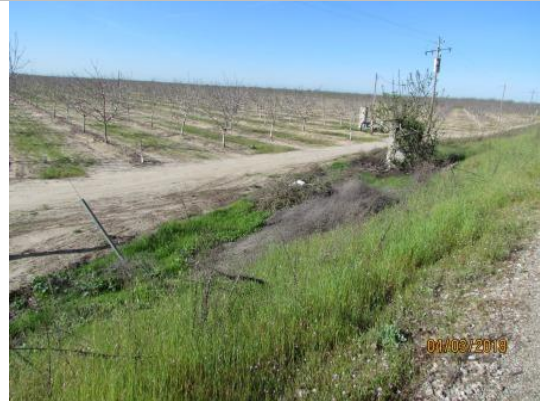
Photo 1 of 1 : SP_2019_RD1001_37_16_20190305_00010.jpg

LM Start	2.58	Rating **	M	Issue No.	16
LM End	2.58	Issue Type +	En	Location *	LS
Category	Earthen Levee			GPS Latitude/Longitude	
				Start	End
Item	Encroachments			38.995610 °	38.995610 °
				-121.417846 °	-121.417846 °
DWR ID	DWR_RD1001_03_s_2017_16				
Comment Code					
PR : Prunings					
Inspector Comment					
Prunings at levee toe need to be removed. Spring 2017.

View of prunings at levee toe landside that need to be removed.

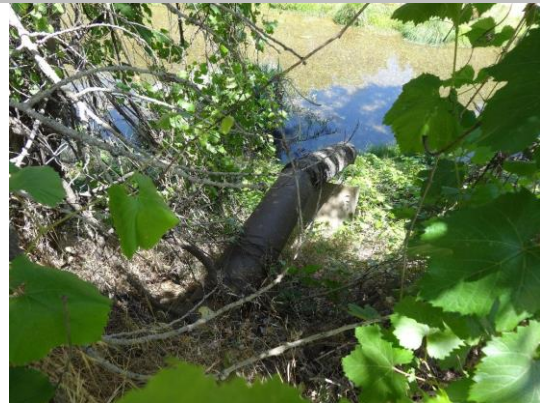
Photo 1 of 2 : UCIP_SP_2019_41722_23338.jpg

Comment Code					
Inspector Comment					
FS_ID:41722 DS_ID:22562 EP_NO: N/A Repair Type: Non-Urgent Crossing Status: Found UCIP Comments: 05/21/2013 Verify pipe has been abandoned properly,- pump mounted on the riverbank not found, - butterfly valve in a 30-inch concrete riser at the waterward toe not found,- concrete box on landside not found- a big tree inside concrete standpipe on landside found. (P. Amatya - DWR UCIP) FIELD_STRUCT_DESC: *ABANDONED* 22-inch steel pipe through the levee, 18.3 feet below the crown. Pump mounted on the riverbank. Butterfly valve in a 30-inch concrete riser at the waterside (WS) toe. Pipe discharges into a concrete box and concrete standpipe on the landside (LS). Steel plate bolted to the WS end of the pipe during the winter months. (California Packing Corporation). [Additional Reference(s): DWR Levee Log, 1993]. FS Date: 5/21/2013

WS- only a steel pipe found on riverbank.

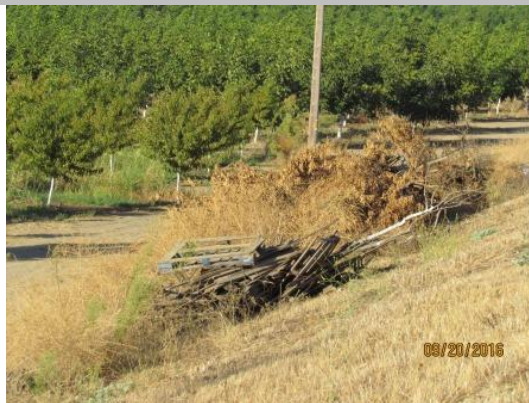
Photo 1 of 1 : SP_2019_RD1001_37_5_20190305_00002.jpg

LM Start	2.73	Rating **	M	Issue No.	5
LM End	2.96	Issue Type +	En	Location *	LS
Category	Earthen Levee			GPS Latitude/Longitude	
				Start	End
Item	Encroachments			38.995107 °	38.994143 °
				-121.420535 °	-121.424529 °
DWR ID	DWR_RD1001_03_f_2015_5				
Comment Code					
PR : Prunings					
Inspector Comment					
Remove trimmings and debris from levee slope, Fall 2017.

View of the prunings at the landside levee toe.

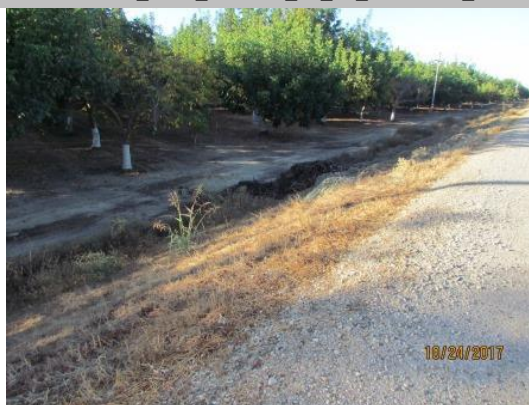
Photo 1 of 1 : SP_2019_RD1001_37_53_20190305_00026.jpg

LM Start	2.99	Rating **	M	Issue No.	53
LM End	2.99	Issue Type +	En	Location *	LS
Category	Earthen Levee			GPS Latitude/Longitude	
				Start	End
Item	Encroachments			38.994036 °	38.994036 °
				-121.425007 °	-121.425007 °
DWR ID	DWR_RD1001_03_f_2017_53				
Comment Code					
PR : Prunings					
Inspector Comment					
Remove prunings from levee slope.

View looking downstream landside of prunings on levee slope.

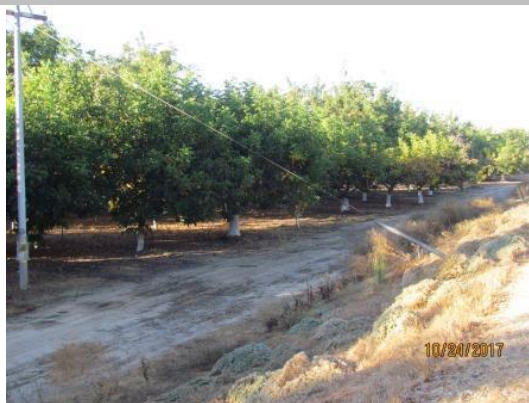
Photo 1 of 1 : SP_2019_RD1001_37_54_20190305_00027.jpg

LM Start	3.03	Rating **	M	Issue No.	54
LM End	3.03	Issue Type +	En	Location *	LS
Category	Earthen Levee			GPS Latitude/Longitude	
				Start	End
Item	Encroachments			38.993838 °	38.993838 °
				-121.425829 °	-121.425829 °
DWR ID	DWR_RD1001_03_f_2017_54				
Comment Code					
PO : Pole					
Inspector Comment					
There is a guy wire in the levee slope near the crown.

View looking downstream landside of a guy wire into the levee slope.

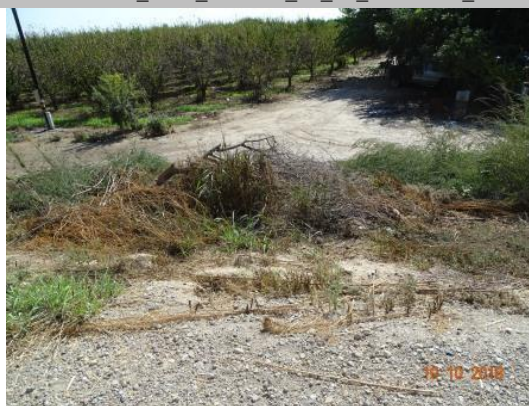
Photo 1 of 1 : SP_2019_RD1001_37_17_20190305_00011.jpg

LM Start	3.46	Rating **	M	Issue No.	17
LM End	3.46	Issue Type +	En	Location *	LS
Category	Earthen Levee			GPS Latitude/Longitude	
				Start	End
Item	Encroachments			38.992021 °	38.992021 °
				-121.433448 °	-121.433448 °
DWR ID	DWR_RD1001_03_f_2018_17				
Comment Code					
DE : Debris					
Inspector Comment

View looking at debris and prunings on the landside levee slope, Fall 2018.

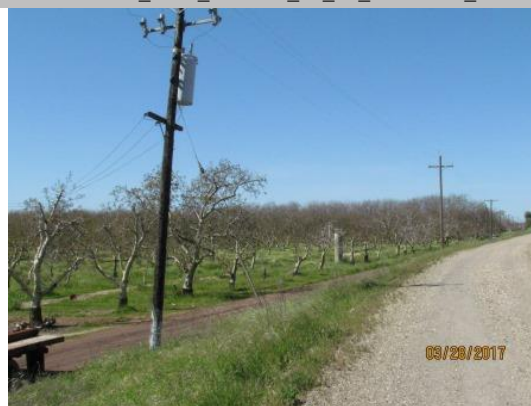
Photo 1 of 1 : SP_2019_RD1001_37_20_20190305_00013.jpg

LM Start	3.61	Rating **	M	Issue No.	20
LM End	3.69	Issue Type +	En	Location *	LS
Category	Earthen Levee			GPS Latitude/Longitude	
				Start	End
Item	Encroachments			38.991230 °	38.991207 °
				-121.435918 °	-121.437433 °
DWR ID	DWR_RD1001_03_f_2016_20				
Comment Code					
PO : Pole					
Inspector Comment					
Unpermitted pole line is located on the landside toe.

View looking downstream of unpermitted pole.

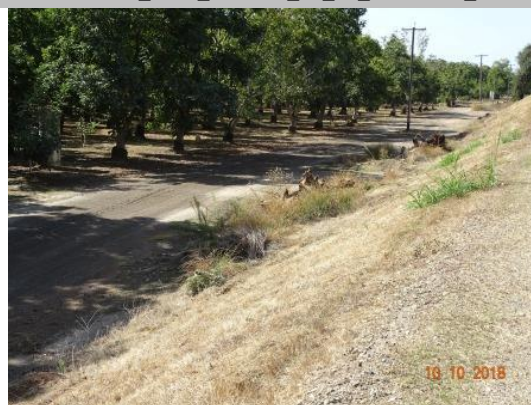
Photo 1 of 1 : SP_2019_RD1001_37_18_20190305_00012.jpg

LM Start	3.78	Rating **	M	Issue No.	18
LM End	3.89	Issue Type +	En	Location *	LS
Category	Earthen Levee			GPS Latitude/Longitude	
				Start	End
Item	Encroachments			38.991220 °	38.991173 °
				-121.439130 °	-121.441249 °
DWR ID	DWR_RD1001_03_f_2018_18				
Comment Code					
PR : Prunings					
Inspector Comment					
Remove stumps from levee toe, Spring 2019.

View looking downstream landside of pushed up stumps at the levee toe, Fall 2018.

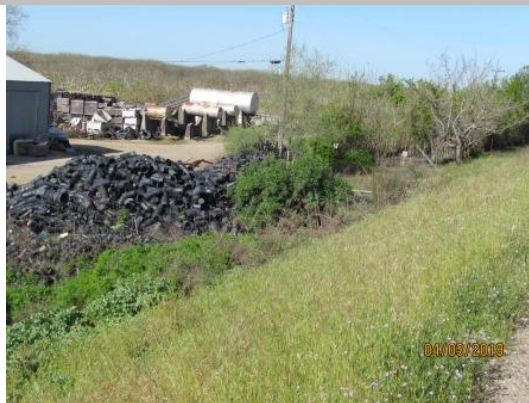
Photo 2 of 2 : SP_2019_RD1001_37_7_20190305_00004.jpg

LM Start	4.01	Rating **	M	Issue No.	7 (cont)	
LM End	4.25	Issue Type +	En	Location *	LS	
Category	Earthen Levee			GPS Latitude/Longitude		
				Start		End
Item	Encroachments			38.991261 °		38.991927 °
				-121.443444 °		-121.447765 °
DWR ID	DWR_RD1001_03_s_2012_7					
Comment Code						
MA : Material						
Inspector Comment						
Land owner continues to leave debris and equipment next to levee toe, Spring 2019.

Irrigation pipe equipment and plastic cans within the easement of the levee.

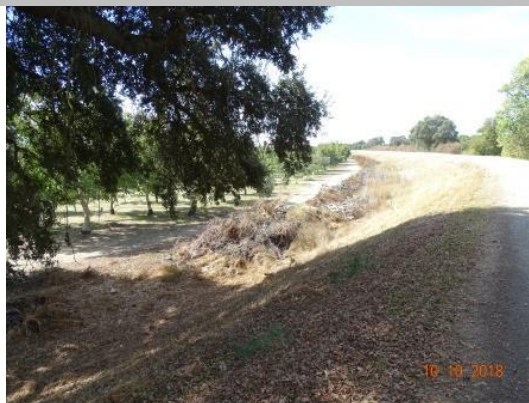
Photo 1 of 2 : SP_2019_RD1001_37_33_20190305_00021.jpg

LM Start	4.26	Rating **	M	Issue No.	33
LM End	4.41	Issue Type +	En	Location *	LS
Category	Earthen Levee			GPS Latitude/Longitude	
				Start	End
Item	Encroachments			38.991981 °	38.991942 °
				-121.447983 °	-121.450668 °
DWR ID	DWR_RD1001_03_s_2017_33				
Comment Code					
PR : Prunings					
Inspector Comment					
Remove prunings at levee toe. Spring 2019.

View looking downstream landside of the same prunings on levee slope from Fall 2017 to Fall 2018.

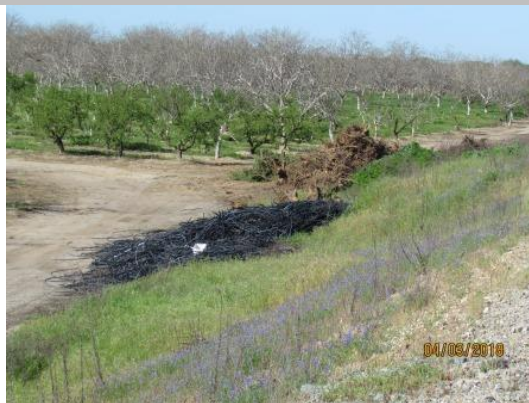
Photo 1 of 1 : SP_2019_RD1001_37_35_20190305_00023.jpg

LM Start	4.47	Rating **	M	Issue No.	35
LM End	4.47	Issue Type +	En	Location *	LS
Category	Earthen Levee			GPS Latitude/Longitude	
				Start	End
Item	Encroachments			38.991864 °	38.991864 °
				-121.451770 °	-121.451770 °
DWR ID	DWR_RD1001_03_s_2017_35				
Comment Code					
LI : Landscape Irrigation					
Inspector Comment					
Remove drip irrigation along levee toe. Spring 2019.

View looking downstream landside of drip irrigation and trash still on levee slope.

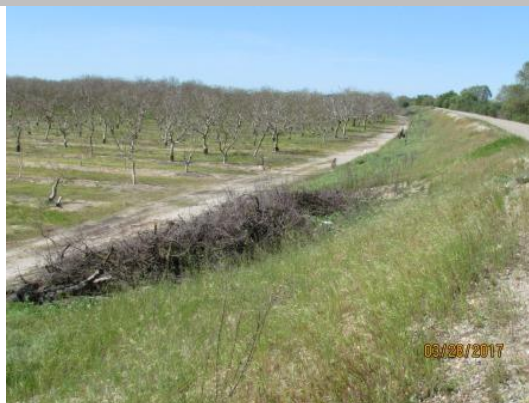
Photo 1 of 1 : SP_2019_RD1001_37_9_20190305_00005.jpg

LM Start	4.47	Rating **	M	Issue No.	9
LM End	4.69	Issue Type +	En	Location *	LS
Category	Earthen Levee			GPS Latitude/Longitude	
				Start	End
Item	Encroachments			38.991862 °	38.991400 °
				-121.451848 °	-121.455901 °
DWR ID	DWR_RD1001_03_s_2013_9				
Comment Code					
PR : Prunings					
Inspector Comment					
Remove prunings from levee toe, Spring 2019.

There is a still a pile of prunings at the toe.

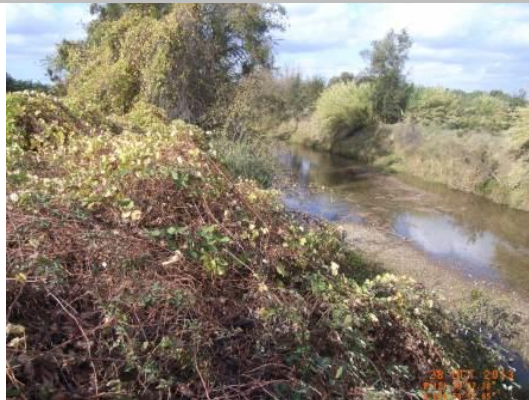
Photo 1 of 1 : SP_2019_RD1001_37_13_20190305_00009.jpg

LM Start	7.22	Rating **	A/W	Issue No.	13
LM End	7.31	Issue Type +	Ma	Location *	WS
Category	Supplemental			GPS Latitude/Longitude	
				Start	End
Item	2017 USACE Erosion Survey, DRAFT			38.982737 °	38.982572 °
				-121.501144 °	-121.502797 °
DWR ID	DWR_RD1001_03_f_2018_13				
Comment Code					
Inspector Comment					
2017 Site ID: BER 5.7 L					
Status: Eroding					
2017 Field Notes: Minor new erosion observed.					
Site History: 2008 - Sandy/silty banks with rotational slab failures creating near vertical bank with pop-outs due to tree failures. Narrow berm.					
Levee Inspector notes: Erosion is not into the levee prism on into the channel bank.

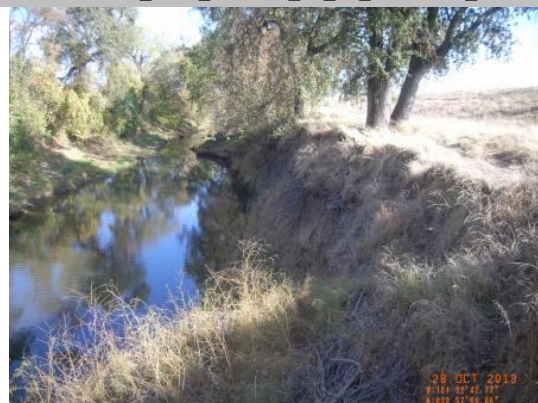
Photo 1 of 1 : SP_2019_RD1001_37_12_20190305_00008.jpg

LM Start	10.36	Rating **	M	Issue No.	12
LM End	10.40	Issue Type +	Ma	Location *	WS
Category	Supplemental			GPS Latitude/Longitude	
				Start	End
Item	2017 USACE Erosion Survey, DRAFT			38.964583 °	38.964010 °
				-121.544967 °	-121.545228 °
DWR ID	DWR_RD1001_03_f_2018_12				
Comment Code					
Inspector Comment					
2017 Site ID: BER 2.5 L					
Status: Eroding					
2017 Field Notes: Erosion pockets have expanded					
Site History: 2011 - Large section of bank has slumped off. RD has flagged and appears to be watching. 2012 - Slopes slightly steeper.					
2013 - Minor new erosion observed.

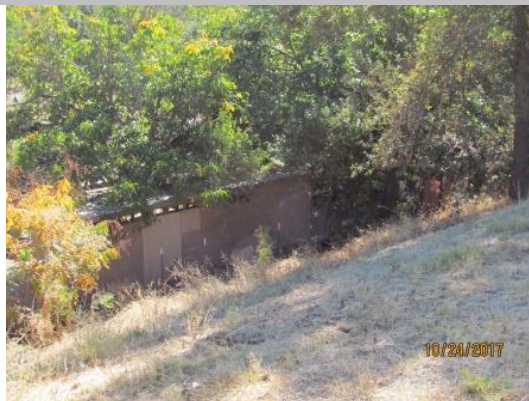
Photo 1 of 1 : SP_2019_RD1001_37_11_20190305_00007.jpg

LM Start	10.49	Rating **	U	Issue No.	11
LM End	10.49	Issue Type +	En	Location *	LS
Category	Earthen Levee			GPS Latitude/Longitude	
				Start	End
Item	Encroachments			38.962770 °	38.962770 °
				-121.545741 °	-121.545741 °
DWR ID	DWR_RD1001_03_f_2015_11				
Comment Code					
BU : Building					
Inspector Comment					
Small sheds are at levee toe, Fall 2017.

View of building at the landside toe.

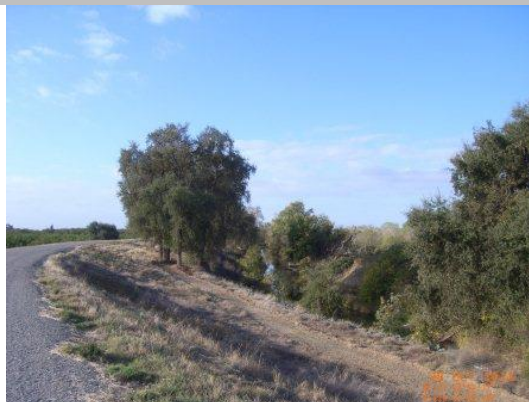
Photo 1 of 1 : SP_2019_RD1001_37_10_20190305_00006.jpg

LM Start	11.08	Rating **	A/W	Issue No.	10
LM End	11.16	Issue Type +	Ma	Location *	WS
Category	Supplemental			GPS Latitude/Longitude	
				Start	End
Item	2017 USACE Erosion Survey, DRAFT			38.955070 °	38.954227 °
				-121.549528 °	-121.550592 °
DWR ID	DWR_RD1001_03_f_2018_10				
Comment Code					
Inspector Comment					
2017 Site ID: BER 1.9 L					
Status: Eroding					
2017 Field Notes: Minor new erosion observed.					
Site History: 2011 - Large slumped sections of bank. 2012 - Slopes slightly steeper.

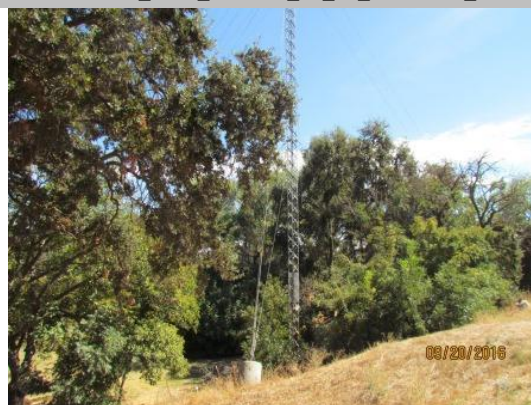
Photo 1 of 1 : SP_2019_RD1001_38_19_20190305_00008.jpg

LM Start	2.27	Rating **	M	Issue No.	19
LM End	2.27	Issue Type +	En	Location *	LS
Category	Earthen Levee			GPS Latitude/Longitude	
				Start	End
Item	Encroachments			38.909790 °	38.909790 °
				-121.574449 °	-121.574449 °
DWR ID	DWR_RD1001_04_s_2013_19				
Comment Code					
PO : Pole					
Inspector Comment

View of power pole and guy wire on the levee slope.

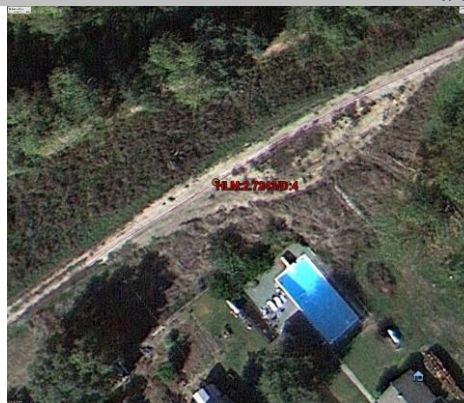
Photo 1 of 1 : UCIP_SP_2019_41987_24126.jpg

LM Start	2.68	Rating **	M	Issue No.	152
LM End	2.68	Issue Type +	En	Location *	
Category	Supplemental			GPS Latitude/Longitude	
				Start	End
Item	DWR UCIP Field Study			38.905089 °	38.905089 °
				-121.578477 °	-121.578477 °
DWR ID	22568				
Comment Code					
Inspector Comment					
FS_ID:41987 DS_ID:22568 EP_NO: N/A Repair Type: Non-Urgent Crossing Status: Indicator Found UCIP Comments: 05/16/2013 Dense vegetation on slopes should be cleared. (P. Amatya - DWR UCIP) FIELD_STRUCT_DESC: 4-inch steel swimming pool drainage pipe through the levee, 3 feet below the crown. Open on the waterside (WS) end. Swimming pool on the landside (LS) toe. (Nate Wise). [Additional Reference(s): DWR Levee Log, 1993]. FS Date: 5/16/2013

LS- only a private swimming pool found.

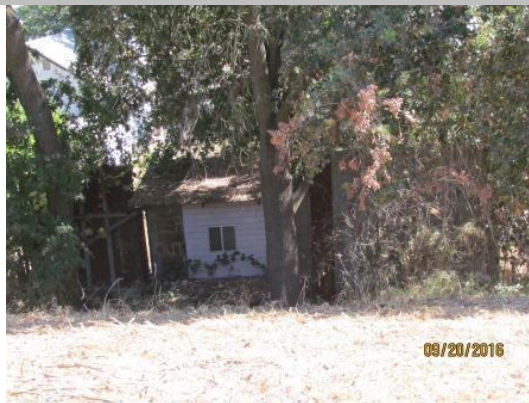
Photo 1 of 1 : SP_2019_RD1001_38_32_20190305_00016.jpg

LM Start	2.70	Rating **	M	Issue No.	32
LM End	2.70	Issue Type +	En	Location *	LS
Category	Earthen Levee			GPS Latitude/Longitude	
				Start	End
Item	Encroachments			38.904898 °	38.904898 °
				-121.578829 °	-121.578829 °
DWR ID	DWR_RD1001_04_f_2016_32				
Comment Code					
BU : Building					
Inspector Comment

View of shed at landside levee toe in the easement.

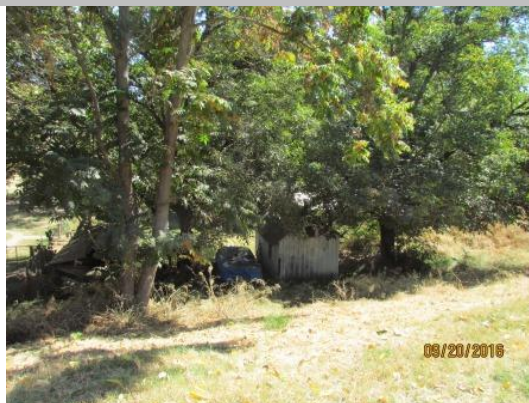
Photo 1 of 1 : SP_2019_RD1001_38_34_20190305_00017.jpg

LM Start	2.76	Rating **	M	Issue No.	34
LM End	2.76	Issue Type +	En	Location *	LS
Category	Earthen Levee			GPS Latitude/Longitude	
				Start	End
Item	Encroachments			38.904351 °	38.904351 °
				-121.579718 °	-121.579718 °
DWR ID	DWR_RD1001_04_f_2015_34				
Comment Code					
BU : Building					
Inspector Comment

View of a shed in the easement of the landside levee.

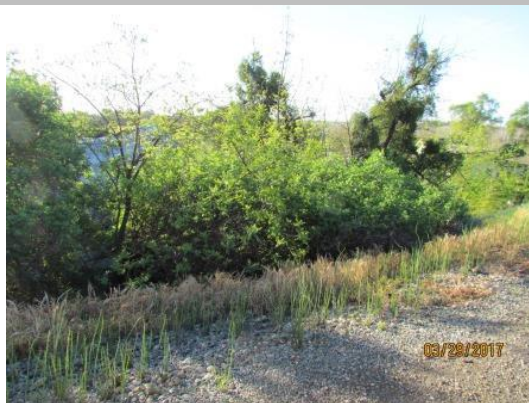
Photo 1 of 1 : SP_2019_RD1001_38_47_20190305_00024.jpg

LM Start	2.80	Rating **	M	Issue No.	47
LM End	2.80	Issue Type +	Ma	Location *	LS
Category	Earthen Levee			GPS Latitude/Longitude	
				Start	End
Item	Trim / Thin Trees			38.903896 °	38.903896 °
				-121.580230 °	-121.580230 °
DWR ID	DWR_RD1001_04_s_2017_47				
Comment Code					
T1 : Trim trees to at least five feet above ground level.					
Inspector Comment					
Trim limbs 5' for visibility.

View looking downstream where limbs need to be trimmed 5' for visibility.

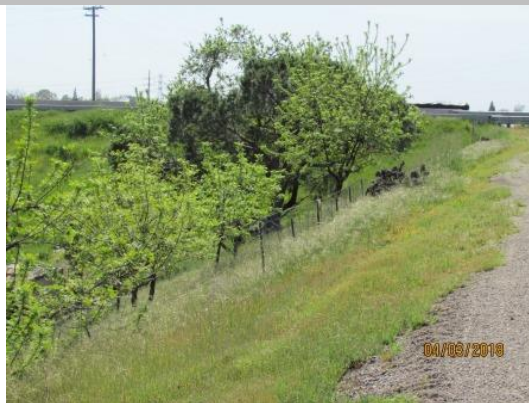
Photo 1 of 2 : SP_2019_RD1001_38_48_20190305_00025.jpg

LM Start	3.16	Rating **	M	Issue No.	48
LM End	3.19	Issue Type +	En	Location *	LS
Category	Earthen Levee			GPS Latitude/Longitude	
				Start	End
Item	Encroachments			38.899835 °	38.899499 °
				-121.583986 °	-121.584462 °
DWR ID	DWR_RD1001_04_s_2017_48				
Comment Code					
FE : Fence					
Inspector Comment					
Fence and landscaping have been placed by the land owner and still exist on levee slope and needs to be removed, Spring 2019.

View looking downstream landside of fence and landscaping that have been placed by the land owner on levee slope and needs to be removed, Spring 2018.

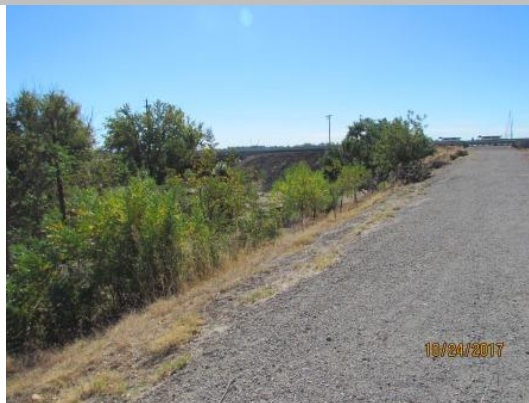
Photo 2 of 2 : SP_2019_RD1001_38_48_20190305_00026.jpg

View looking downstream of fence and landscaping that have been placed by the land owner on levee slope and needs to be removed, Fall 2017.

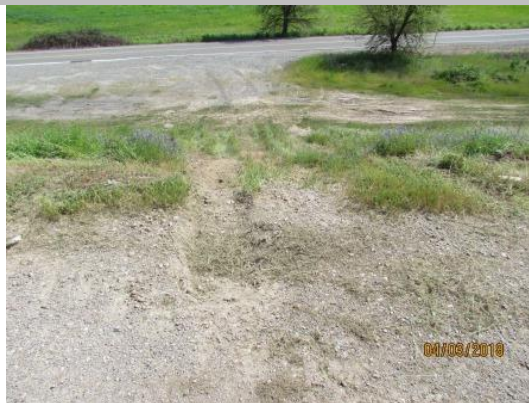
Photo 1 of 1 : SP_2019_RD1001_38_51_20190305_00027.jpg

LM Start	4.06	Rating **	A/W	Issue No.	51
LM End	4.09	Issue Type +	Ma	Location *	LS
Category	Earthen Levee			GPS Latitude/Longitude	
				Start	End
Item	Slope Stability			38.892820 °	38.892583 °
				-121.598003 °	-121.598575 °
DWR ID	DWR_RD1001_04_s_2017_51				
Comment Code					
S3 : Repair the levee slope damaged by vehicle traffic and prevent access where possible.					
Inspector Comment					
Continual vehicles driving up levee slope should be monitored and maintained, Spring 2018.

View of continual vehicles driving up levee slope, should be monitored and maintained.

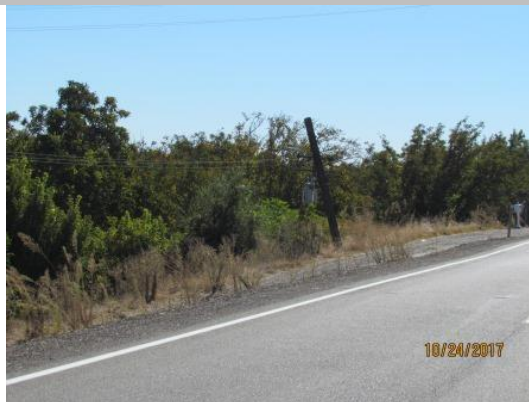
Photo 1 of 1 : SP_2019_RD1001_38_27_20190305_00012.jpg

LM Start	5.71	Rating **	M	Issue No.	27
LM End	5.71	Issue Type +	En	Location *	LS
Category	Earthen Levee			GPS Latitude/Longitude	
				Start	End
Item	Encroachments			38.874984 °	38.874984 °
				-121.614242 °	-121.614242 °
DWR ID	DWR_RD1001_04_s_2015_27				
Comment Code					
PO : Pole					
Inspector Comment					
Remove pole on levee slope, Fall 2018.

View of pole on landside, no lines connected to it.

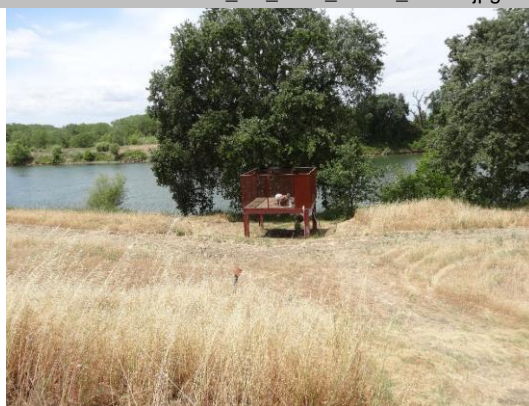
Photo 1 of 3 : UCIP_SP_2019_14604_24107.jpg

Comment Code						
Inspector Comment						
FS_ID:14604 DS_ID:22573 EP_NO: 10389 Repair Type: Non-Urgent Crossing Status: Found UCIP Comments: 01/24/2019 Project modification logged under Permit 10389-A-1 proposes removing and replacing existing 12-inch pressurized water pipe and conduit. Need to determine construction start date and obtain as-built drawing for new pipe. Pending actions: need to issue new UCIP dsid for new pipe and retire current dsid 22573. (O. Magana - DWR UCIP) 05/16/2013 - water leakage causes erosion on LS slope.- may be pressure breaker valve not closed properly on LS.- a 36-inch concrete standpipe at the landward toe not found. (P. Amatya - DWR UCIP) FIELD_STRUCT_DESC: 12-inch irrigation discharge pipe of an unknown material through the levee, 10 feet below the crown. 30-horsepower slant pump on the riverbank. Siphon breaker in a 24-inch corrugated metal pipe (CMP) riser on the landside (LS) slope. Pipe discharges into a 36-inch concrete standpipe at the LS toe. Pipe installed by USACE in 1963. Switch panel and service pole at the LS toe. (12-inch pipe and a 30-horsepower slant pump authorized under Permit No. 10389-A, 1974 - Pluma Orchards, also includes removal of existing pipe). [Additional Reference(s): DWR Levee Log, 1993]. FS Date: 5/16/2013

WS- slanted pump station on steel platform on levee berm.

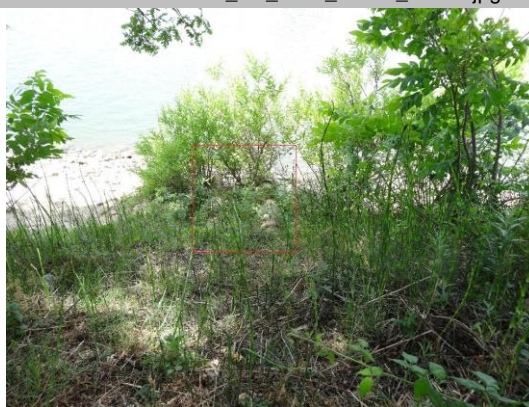
Photo 2 of 3 : UCIP_SP_2019_14604_24106.jpg

WS- inlet pipe on the river bank.

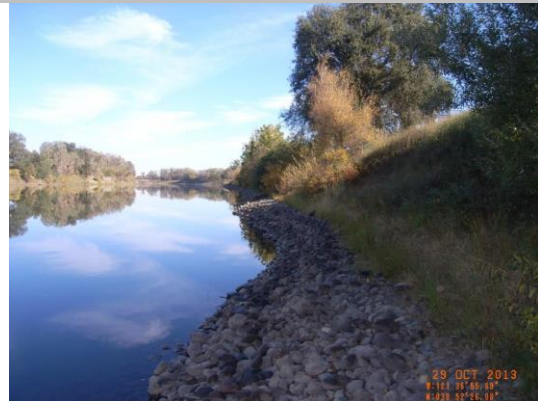
Photo 1 of 1 : SP_2019_RD1001_38_28_20190305_00013.jpg

LM Start	5.80	Rating **	A/W	Issue No.	28
LM End	5.93	Issue Type +	Ma	Location *	WS
Category	Supplemental			GPS Latitude/Longitude	
				Start	End
Item	2017 USACE Erosion Survey, DRAFT			38.874113 °	38.872373 °
				-121.615380 °	-121.616504 °
DWR ID	DWR_RD1001_04_f_2018_28				
Comment Code					
Inspector Comment					
2017 Site ID: FHR 6.6 L Status: Eroding 2017 Field Notes: Sandy bank slope is unraveling. Site History: 2011 - Erosion pockets from tree popouts. Sections of the lower bank have slumped off. 2013 - Scallop from tree popouts no longer visible on site. Minor new erosion at the middle of the bank. 2015 - Fresh erosion from human usage.

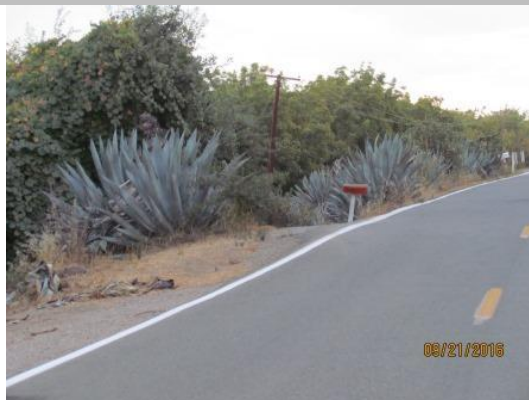
Photo 1 of 1 : SP_2019_RD1001_38_17_20190305_00006.jpg

LM Start	6.39	Rating **	U	Issue No.	17
LM End	6.46	Issue Type +	En	Location *	LS
Category	Earthen Levee			GPS Latitude/Longitude	
				Start	End
Item	Vegetation			38.866032 °	38.865195 °
				-121.619489 °	-121.620017 °
DWR ID	DWR_RD1001_04_s_2012_17				
Comment Code					
V6 : Landscaping					
Inspector Comment					
Home owners landscaping should be removed, Fall 2018.

View of landscaping on the landside shoulder and slope looking downstream.

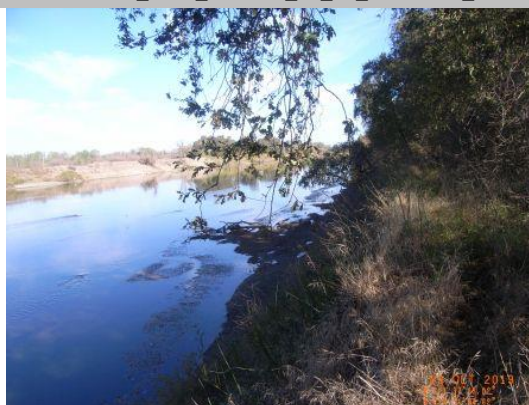
Photo 1 of 1 : SP_2019_RD1001_38_18_20190305_00007.jpg

LM Start	6.42	Rating **	M	Issue No.	18
LM End	6.51	Issue Type +	Ma	Location *	WS
Category	Supplemental			GPS Latitude/Longitude	
				Start	End
Item	2017 USACE Erosion Survey, DRAFT			38.865875 °	38.864706 °
				-121.619983 °	-121.620813 °
DWR ID	DWR_RD1001_04_f_2018_18				
Comment Code					
Inspector Comment					
2017 Site ID: FHR 6.0 L					
Status: Critical					
2017 Field Notes: Upgraded to critical, entire bank slope is slumping, with near vertical face					
Site History: 2011 - Tall slumping sections. Scour around trees has exposed most of the roots. 2016 - Recent large slope failure observed.					
Inspector notes: The erosion is not into the levee prism. Spring 2019.
